# Building Survey

**November 2017**

Moadlock  
Romiley

Building Survey  
November 2017

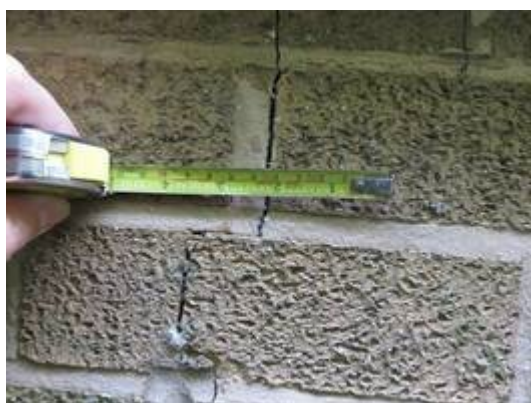
1. Vertical and stepped cracking to chimney breast to South elevation
2. Vertical cracking below bedroom window to North elevation
3. Vertical cracking below bedroom window to West elevation

A Structural Engineers report prepared by Rhodes and Partners was passed to us during our inspection which detailed and commented on the cracks in points 2 and 3 above, a copy of their findings is also included within the rear of this report. In brief it suggests the cracks are due to moisture movement and now movement has virtually ceased. As no defects were noted internally to the corresponding areas, these cracks were not considered progressive.

Cracking below window to North elevation

No.	Issues identified	Category
1	Repoint cracking to bricks and mortar in all locations	2
2	Obtain details of the cavity wall insulation installed	2

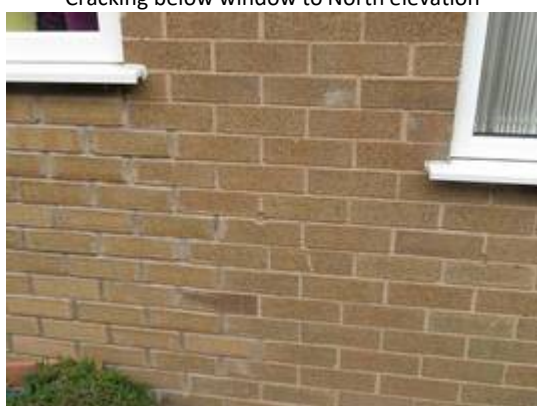
4.2.7 There was evidence of retrospectively applied cavity wall insulation having been provided to the property in various locations as holes were noted which were then filled in with mortar. Incorrectly specified or applied cavity wall insulation can cause excessive levels of condensation internally, no evidence of this was noted.

Mortar filled hole due to cavity wall insulation

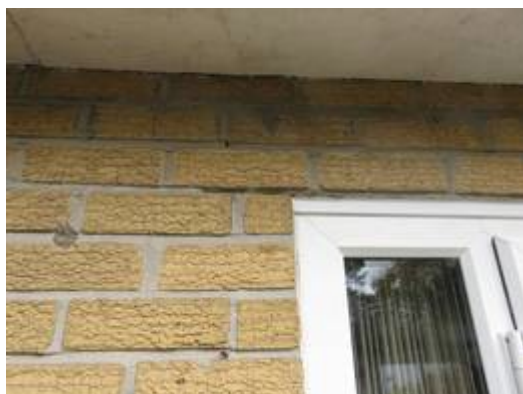
4.3.1 Window and door openings require lintels (small beams) to support the brickwork above. Steel lintels are present above all the openings where brickwork is supported above. We were able to inspect all of the lintels and whilst all of the lintels were performing adequately with no deficiencies noted, minor surface corrosion was noted to the lintel above the external door serving the rear lounge. Corroding lintels can cause the brickwork to split and in extreme cases the lintel will require replacement, the corrosion noted was minor, however this should be treated with the remaining lintels monitored.

Minor corrosion to lintel above rear lounge external door

No.	Issues identified	Category
1	Treat lintel above rear lounge external door with suitable rust inhibitor	2
2	Monitor remaining lintels	2

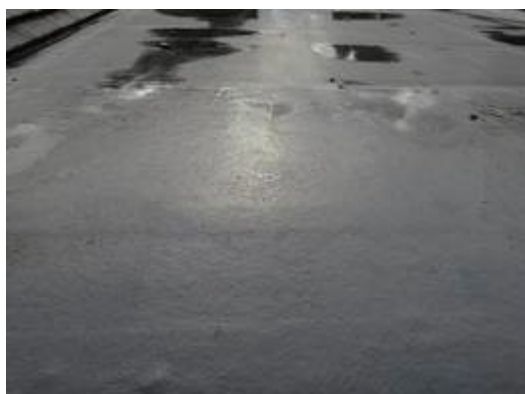
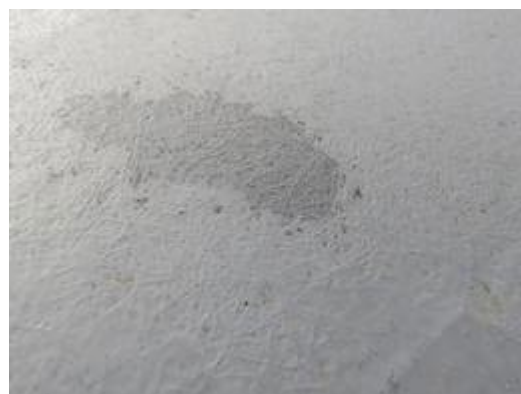
Visible fibre glass to rear flat roof

No.	Issues identified	Category
1	Consider application of another layer to liquid roofs	3
2	Obtain copies of the building control consent for the new pitched roof	2
3	Request copies of the guarantee for the liquid flat roof	1

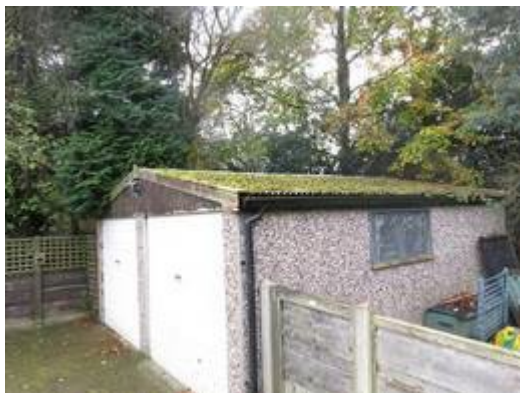
Double garage to rear of garden
